Subject: Quarterly Report 45 - Addendum  
Civil Action No. 3:08-cv-00608-CRS

Please find attached an addendum to our Quarterly Report, prepared in accordance with Paragraph 29 of our Amended Consent Decree. This report is for the period October 1, 2016 – December 31, 2016, pertaining to Consent Decree compliance activities.

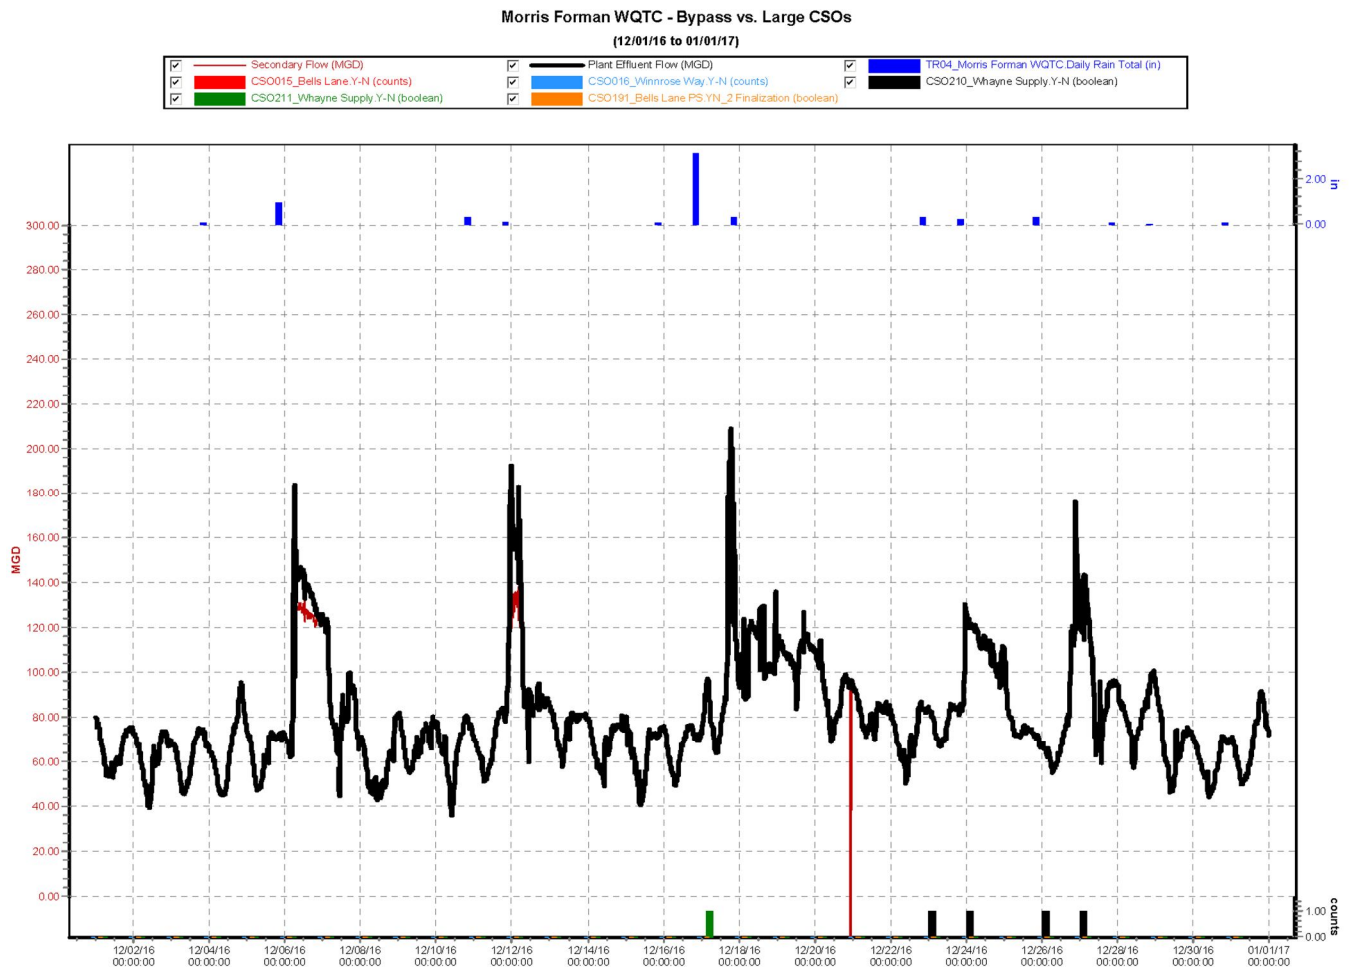
On page 12, Figure 1.4 Morris Forman WQTC – Plant Flows and Associated CSO Activations – December 2016 showed a negative spike in secondary flow that was not addressed in the text. When the Final Effluent Pump Station (FEPS) is not in service, secondary flow is a direct measurement from the effluent flume. When FEPS is in service, the flow is calculated. On December 20, 2016, there was a power failure that impacted the Oxygen Generation Area and the flow reporting for secondary effluent from 10:11 PM through 10:52 PM. During this time, FEPS was in service, and the power outage appears to have corrupted the flow calculation so that secondary effluent flow was reported as a negative value.

Figures 1.2 through 1.4 located at the end of this section illustrate performance in maximizing flow during wet weather to the Morris Forman WQTC. The top of the chart shows rainfall in inches per day. The middle part of the chart shows Morris Forman WQTC effluent flow and secondary treatment flow. The difference between these is the secondary bypass flow. The bottom of the chart shows days with a CSO activation at the five CSOs in the vicinity of the Morris Forman WQTC (CSOs 015, 016, 191, 210, and 211). Note that the flow meter downstream from CSO211 is known to be affected by backwater effects of the Ohio River and the ultrasonic signal is sometimes blocked by mist and condensation when air and sewage temperatures are significantly different. Therefore, CSO activations at CSO211 are keyed to water levels upstream and downstream of the inflatable dam in the Main Diversion Structure. The other CSO activations are tied to flow measurement downstream of the respective CSO. At times, “blips” representing very small volumes of overflow are indicated by flow meters even though an overflow cannot be verified by level measurements or other indicators. These blips are not reported as overflows, but are noted in the CSO monitoring data reported in Appendix B. There are occasions in which a communications failure with telemetry has led to short-term gaps in the data, as illustrated by the negative spike in secondary flow shown on December 20, 2016, when a

power failure occurred that impacted the Oxygen Generation Area and the flow reporting for secondary effluent. When the Final Effluent Pump Station (FEPS) is not in service, secondary flow is a direct measurement from the effluent flume. When FEPS is in service, the flow is calculated. During this time, FEPS was in service, and the power outage appears to have corrupted the flow calculation from 10:11 PM through 10:52 PM so that secondary effluent flow was reported as a negative value. In addition, indications of rainfall and CSO activations are shown on the day they happened, but are not aligned with the exact time, so the effluent flow graph (which is tied to actual time) may show peaks that are offset from the indicated rain or CSO events by as much as 24 hours, as illustrated by the CSO event shown on October 1, 2016 that was caused by a rain event that began on September 28, 2016 and ended September 30, 2016.
