Updated Sanitary Sewer Overflow Plan February 10, 2006

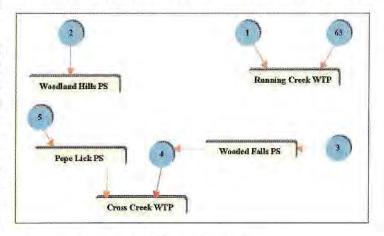
Figure 7 - Pope Lick Flow Monitoring Schematic

Results from the monitoring indicated each of the sites in the Pope Lick basin experienced some amount of I/I during rain events. The hydrographs showed that some areas experienced more inflow than infiltration and vice versa. Many sites experienced immediate increases in flow rate after rain events, indicating inflow sources in the system. There were also a significant amount of surcharges throughout the system.

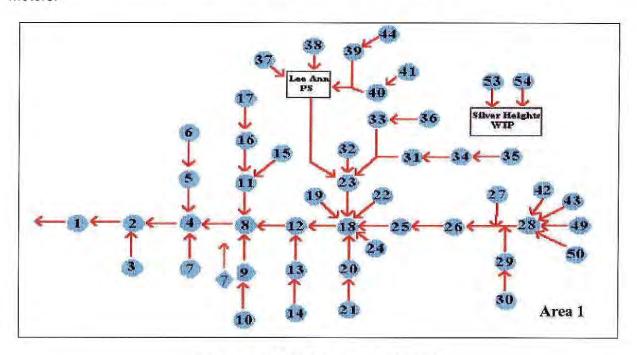
Figure 9 - Pond Creek Flow Monitoring Schematic

This study was developed to characterize and help prioritize the 48 sub-basins in Pond Creek for further study and rehabilitation through the analysis of wet and dry-weather flow data, customer sewer backup complaints, and MSD SSO reporting. Monitors were maintained and data collected for a period of 45 days beginning April 13, 1998, and ending May 27, 1998. The following figure shows a flow monitoring schematic of the sewer systems in the Pond Creek study area. The numbered circles in Figure 9 represent the basins monitored by each of the flow meters.

Three significant rain events were monitored: April 16 (1.96"), April 29-30 (1.66"), and May 23 (0.82"). All of the sites in the Pond Creek basin experienced some amount of inflow/infiltration (I/I) during these rain events. Hydrograph analysis shows that some areas experience more inflow than infiltration and vice versa. Many sites experienced immediate increases in flow rate after rain events, indicating inflow sources in the system. There were also significant periods of surcharging throughout the system.

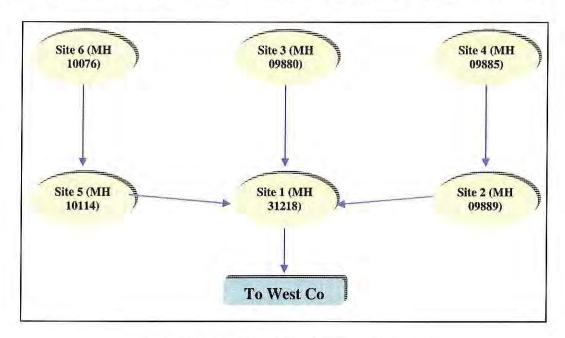
Figure 25 - Valley Village Flow Monitoring Schematic

numbered circles in Figure 25 represent the basins monitored by each of the flow meters. This project cost is included in the total cost for the Valley Village SSES discussed in section 6.2.4.3.

Flow monitoring results showed each site had high peaking factors - ranging from 14 to 32 - except for basin 2. In basin 2, dry weather flow was not considered reliable and it is likely that this basin had high peaking factors as well. In three cases, flow caused the sewers to surcharge.

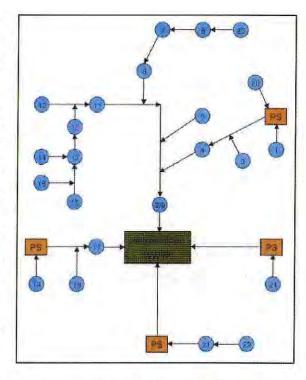
Figure 8 - Jeffersontown Flow Monitoring Schematic

Two significant rain events were monitored: October 3 (1.24"), and October 7 (1.72"). All of the sites in Jeffersontown experienced some amount of inflow/infiltration (I/I) during these rain events. Many sites experienced immediate

increases in flow rate after rain events, indicating significant inflow sources. Flow monitoring results revealed that peaking factors ranged from 1.86 to 10.25 for the sub-basins. Approximately one-third of the sub-basins in the Jeffersontown area had a peaking factor greater than 4. The sub-basins with the highest peaking factors were scattered through Jeffersontown and include portions of the original residential area, the southern industrial park area, and two relatively new areas (Chenoweth Run and Stone Lakes Farm). Basement flooding occurred mainly in the residential areas west and north of Chenoweth Run Creek and was not necessarily related to sub-basins with high peaking factors. The basins were prioritized according to peaking factor, number of basement backups, and other wet weather impacts to form a rehabilitation strategy for the Jeffersontown sanitary sewer system. This project cost approximately \$161,000 and was completed in June 1999.
