State of the Streams

2011 WATER QUALITY SYNTHESIS REPORT

1. Executive Summary

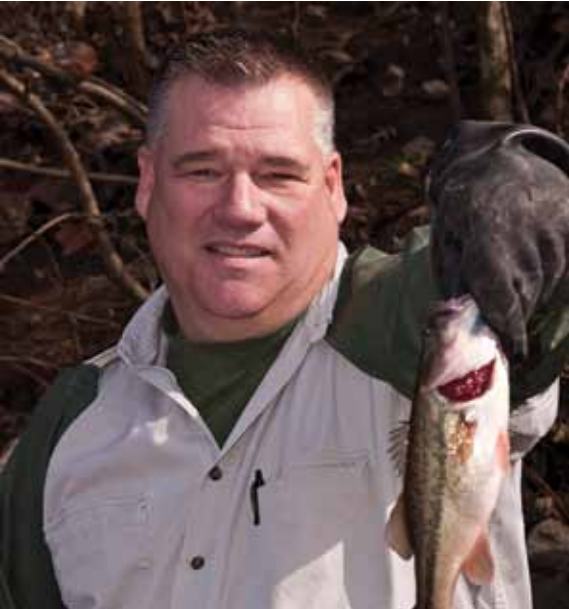
MSD employee conducts fish sampling.

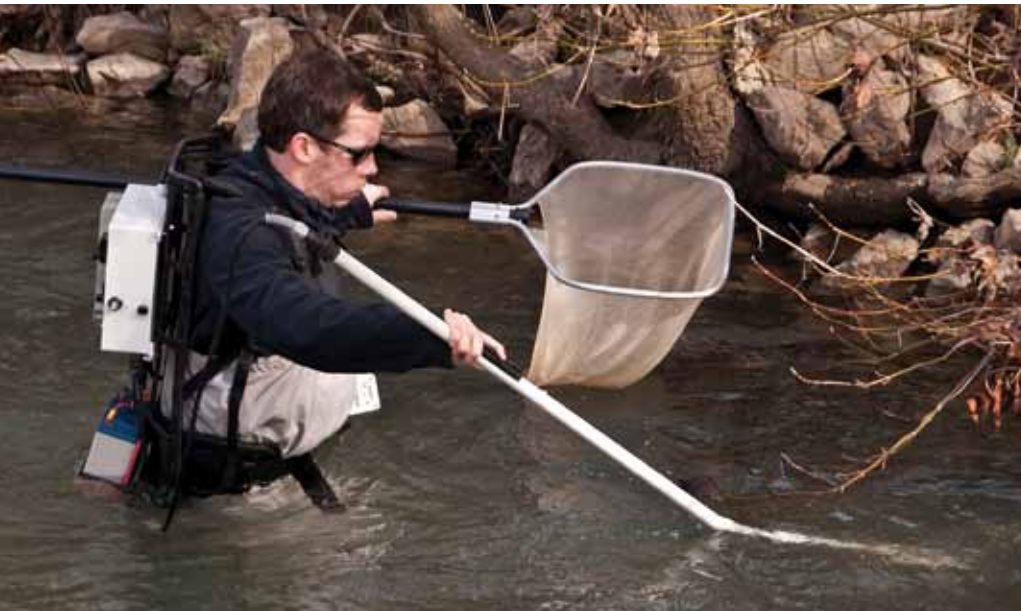
Professional biologists collect fish using a backpack shocker. Most fish are caught, identified in the field and released unharmed back to the stream.

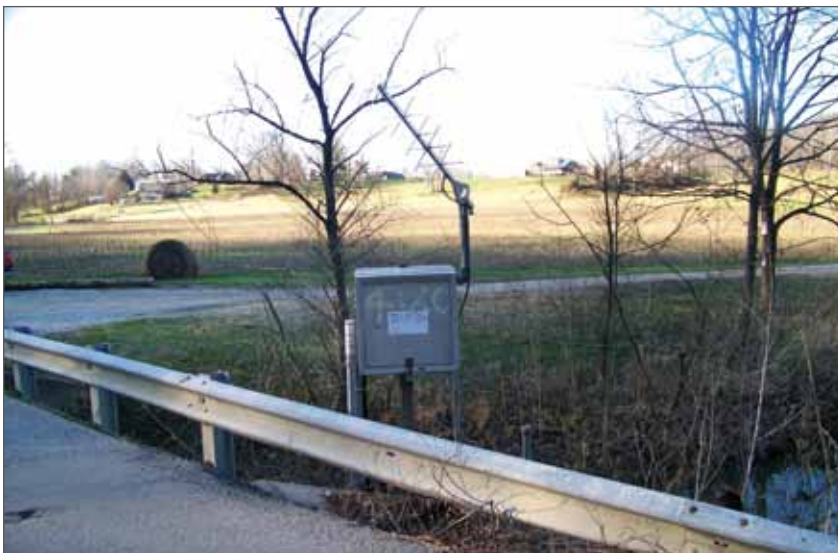
This USGS flow gage (gray box) is located on Brier Creek at Bear Camp Road. The gage is used to continuously monitor dissolved oxygen and stream flow. The antenna on top transmits data for real time monitoring results.

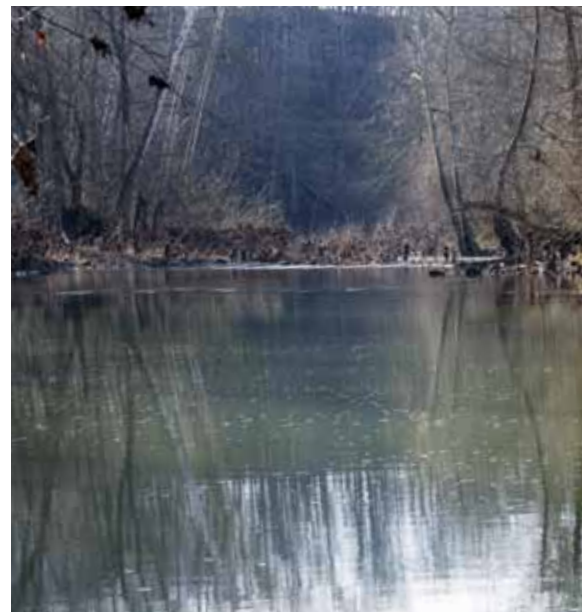
Trees help to stabilize stream on Harrods Creek upstream of Covered Bridge Road

MSD assessed habitat for fish and aquatic insect communities in 2005 and 2008. In Harrods Creek, habitat was classified as “good” in both years. Habitat quality improved from “poor” to “fair” in Wolf Pen Branch between 2005 and 2008. Sediment deposition, unstable banks and a lack of trees and other protective vegetation on the banks were identified in both of these streams.

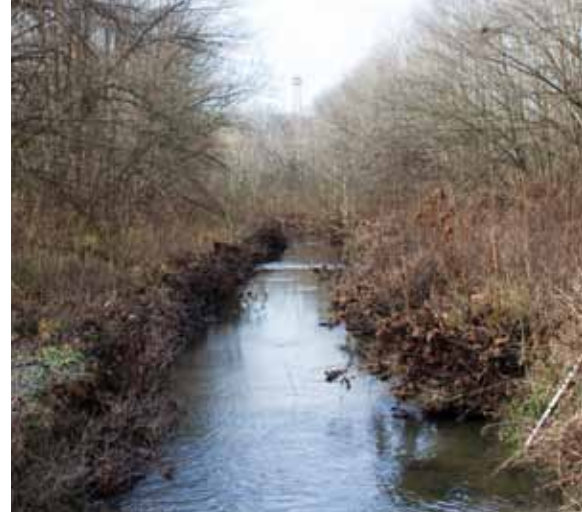
Straightened channel and eroding banks contribute to “poor” habitat along Muddy Fork.

MSD assessed stream habitat conditions for fish and aquatic insect communities in 2005 and 2008 at the Mockingbird Valley Road site. Stream habitat was classified as “poor” both in 2005 and 2008, with some improvement in 2008 but not enough to change the classification. The poor quality habitat is associated with straightening of the channel, lack of trees and other protective vegetation along the stream banks and eroding banks. These issues have contributed to silt and sediment accumulating in the stream, which covers habitats used by aquatic insects and fish.

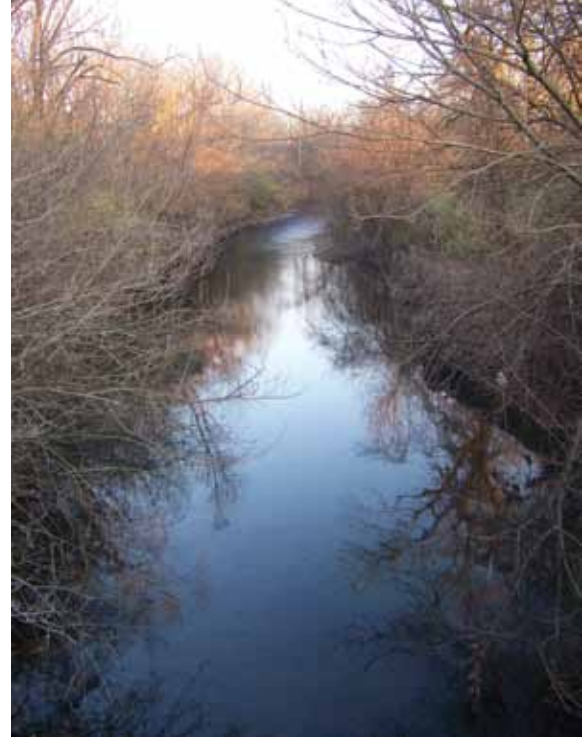
Forest along Middle Fork of Beargrass Creek contributes to “good” habitat at Old Cannons Lane.

MSD assessed stream habitat for fish and aquatic insect communities in 2005 and 2008. The aquatic habitat at Browns Lane was “good” and improving, consistently “good” at Old Cannons Lane and “good” and improving at Lexington Road. Similar to many urban streams, the habitat assessment noted a lack of trees and other protective vegetation along stream banks.

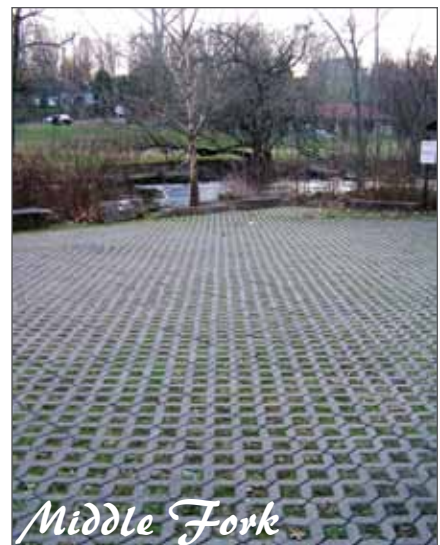
Pervious pavement reduces direct stormwater runoff to streams.

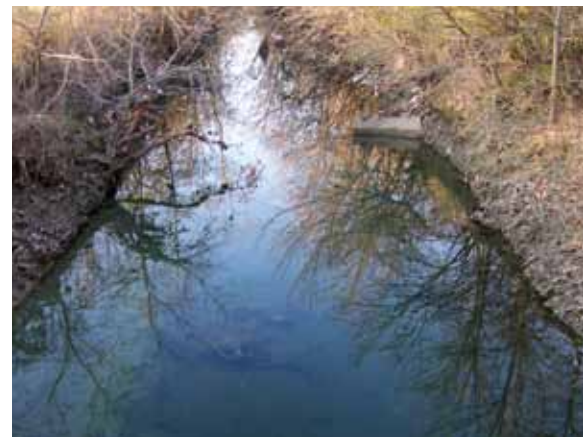
Eroding banks, silt and sediment deposits contribute to “poor” habitat at Trevilian Way

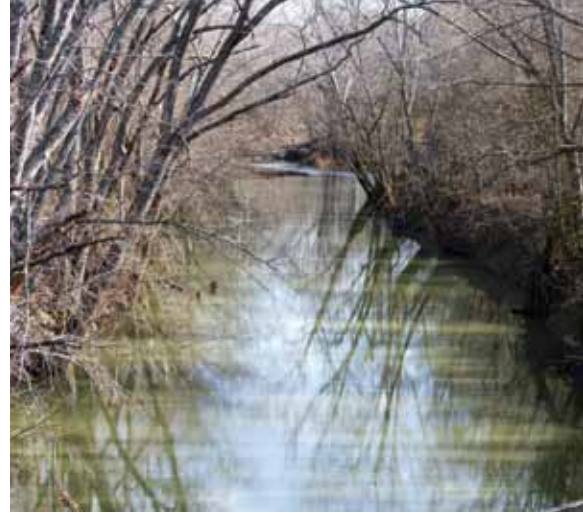
Tree along the banks contribute to “good” habitat in Floyds Fork at Ash Avenue.

MSD assessed stream habitat for fish and aquatic insect communities in 2005 and 2008. At the three Floyds Fork sites, stream habitat was classified in “good” condition in 2008. In Chenoweth Run at Ruckriegel Parkway, habitat was classified as “poor” in both 2005 and 2008, but improving. In Chenoweth Run at Gellhaus Lane, habitat was “good” and improving. Sediment deposition, unstable banks and a lack of trees and other protective vegetation were identified at Ruckriegel Parkway as limitations of the habitat quality. Gellhaus Lane lacked rocky riffles that are used as habitat by aquatic insects.

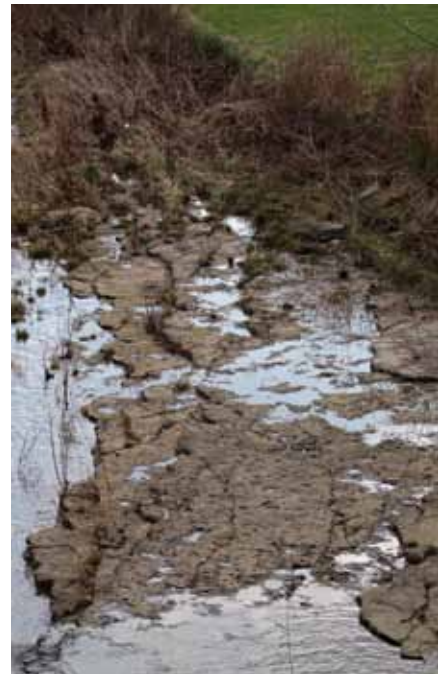
Exposed bedrock in Cedar Creek prevents formation of deep pool habitat.

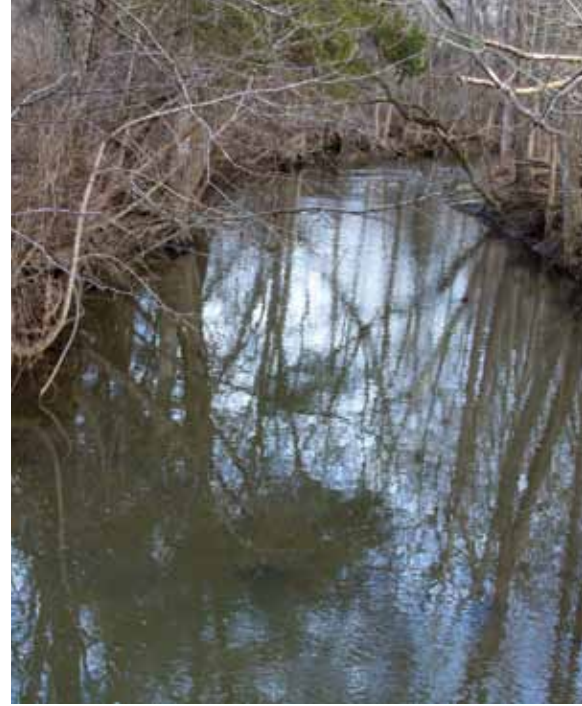
Habitat improved from “poor” to “good” in Pennsylvania Run.

MSD assessed the quality of habitat for fish and aquatic insect communities in 2005 and 2008. Habitat quality improved from “poor” in 2005 to “good” in 2008. At the monitoring site, the stream banks have some stability problems and the stream lacks shallow, rocky riffles that provide good habitat for aquatic insects and fish. The stream channel had not been straightened or otherwise altered.

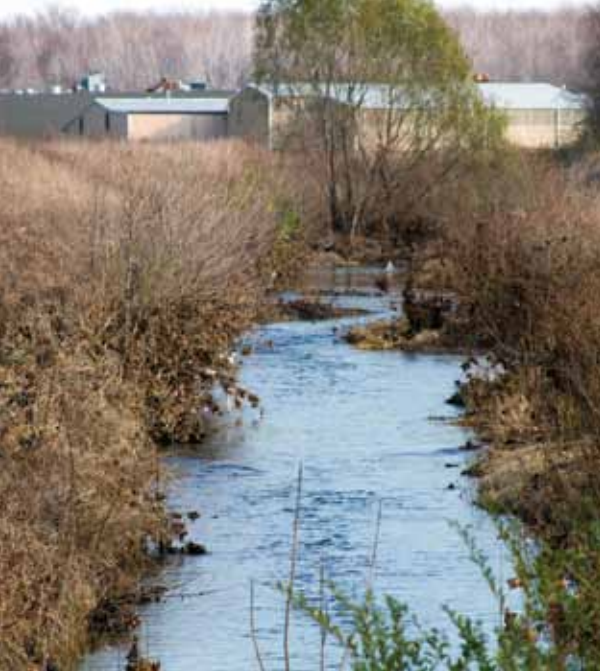
Habitat along Northern Ditch lacks tree cover and deep pools.

Habitat quality improved in Fern Creek from "poor" to "fair" but was stable at the remaining sampling locations; "poor" at Northern Ditch and Pendleton Road, and "good" at the Manslick Road. Typical of many urban streams, the habitat in the Pond Creek watershed is compromised by insufficient trees and other protective vegetation along the banks, erosion and sediment deposition. Both Northern Ditch and Pond Creek at Manslick Road sites are located in a man-made channel, so many of the features of a natural channel such as a mix of rocky riffles and deep, slow pools, submerged logs and undercut banks are not present. In Brier Creek, habitat quality was "poor" to "fair". Habitat in this location lacked trees and other vegetation along the banks, resulting in unstable banks, silt and sediment deposits in the stream. This monitoring site also has a very small drainage area, and is affected

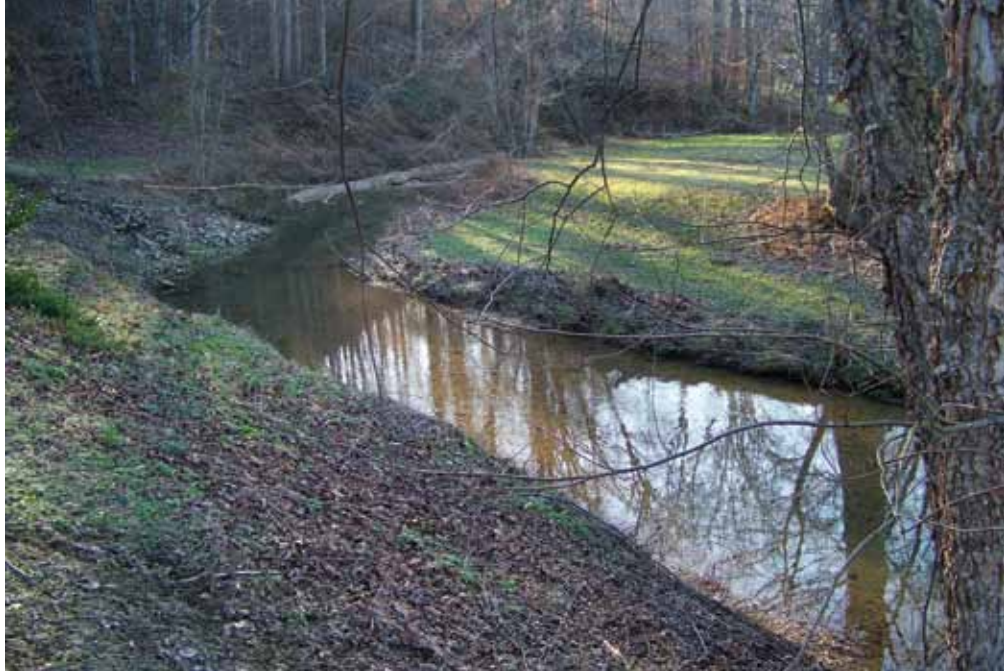
Although picturesque, Brier Creek lacks a stable rocky bottom more suitable for fish and insect habitat.

In Brier Creek at Bear Camp Road, habitat quality was “poor” in 2005 and “fair” in 2008. Habitat in this location lacked trees and other vegetation along the banks, resulting in unstable banks, silt and sediment deposits in the stream. These deposits can cover habitat used by aquatic insects and fish. This monitoring site also has a very small drainage area, and is quickly affected by periods of low stream flow.

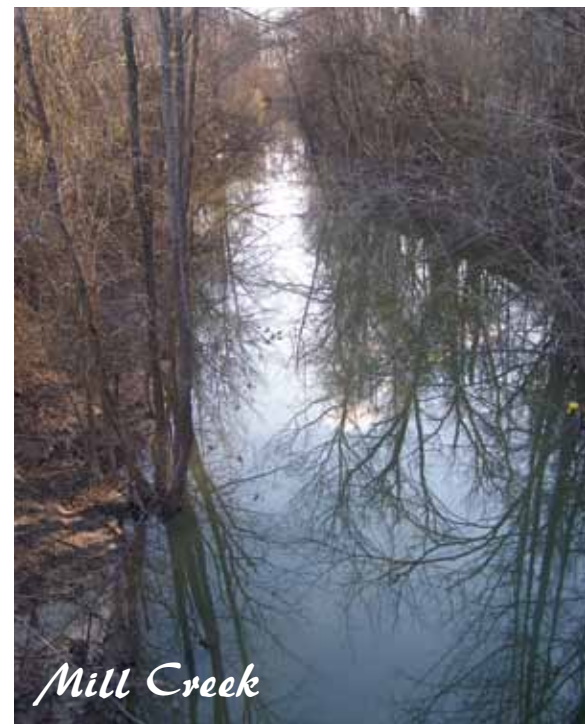
Dissolved Oxygen Conditions in Mill Creek Watershed

MSD and the US Geological Survey continuously monitor dissolved oxygen in Mill Creek at Orell Road (USGS gage 03294570). Fish and aquatic insects need dissolved oxygen to breathe, and amounts greater than five parts per million are what is deemed necessary. More than half of the daily data was available for 2005, 2007 and 2008 in Mill Creek at Orell Road, indicating improving data quality. During this period, the percent of days when the average amount of dissolved oxygen in the water was above five parts per million increased from “poor” in 2005 to “fair” in 2006 through 2008.

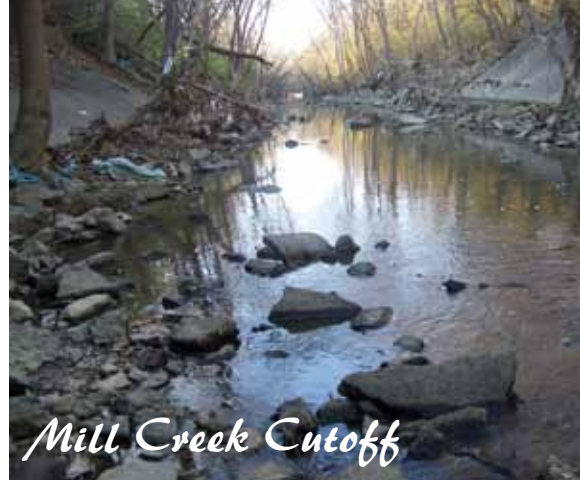
In Mill Creek Cutoff, fish communities have improved from “poor” to “fair” between 1999 and 2008. Aquatic insect communities were “poor” but showing some improvement. Habitat conditions improved to “good” in 2008. Stream flows were below normal in 2005 and 2008. Dissolved oxygen was not collected. Mill Creek Cutoff is a man-made channel to divert flood waters directly to the Ohio River. In spite of good habitat, it is not clear what contributed to the poorer aquatic communities in this stream beyond the natural effects of low stream

flow. In Mill Creek at Orell Road, fish communities were consistently “poor” and aquatic insect communities were “fair” and declining slightly. Aquatic habitat was consistently “fair” and stream flow was below normal. Dissolved oxygen was improved from “poor” to “fair”. The low dissolved oxygen, less than ideal habitat, and low stream flows likely have stressed aquatic communities, particularly during 2008.

At the Mill Creek Cutoff monitoring site, the stream consists of a man-made channel, so many of the features of a natural channel, such as a mix of rocky riffles and deep, slow pools, submerged logs and vegetated banks are not present. These features provide important habitat for fish and aquatic insects. The stream banks do not have sufficient vegetation to protect them from erosion. At the Orell Road monitoring site, the channel has also been altered, and the stream banks also lack sufficient trees for shade and other vegetation to protect them from erosion.
