STATE OF THE STREAMS

2016 WATER QUALITY SYNTHESIS REPORT

EXECUTIVE SUMMARY

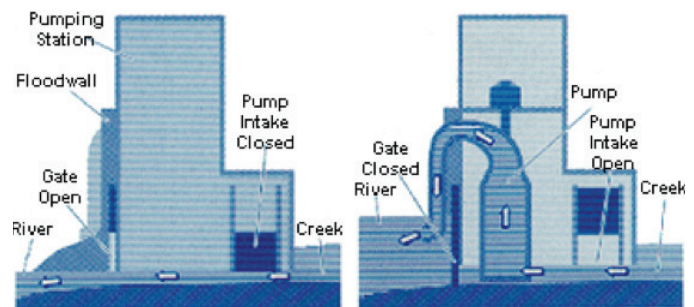
How a flood pumping station works:

River Normal

When the river (left) is at its normal level, the gate in the river side of the pumping station is open and the pump intake closed. The creek flows through into the river.

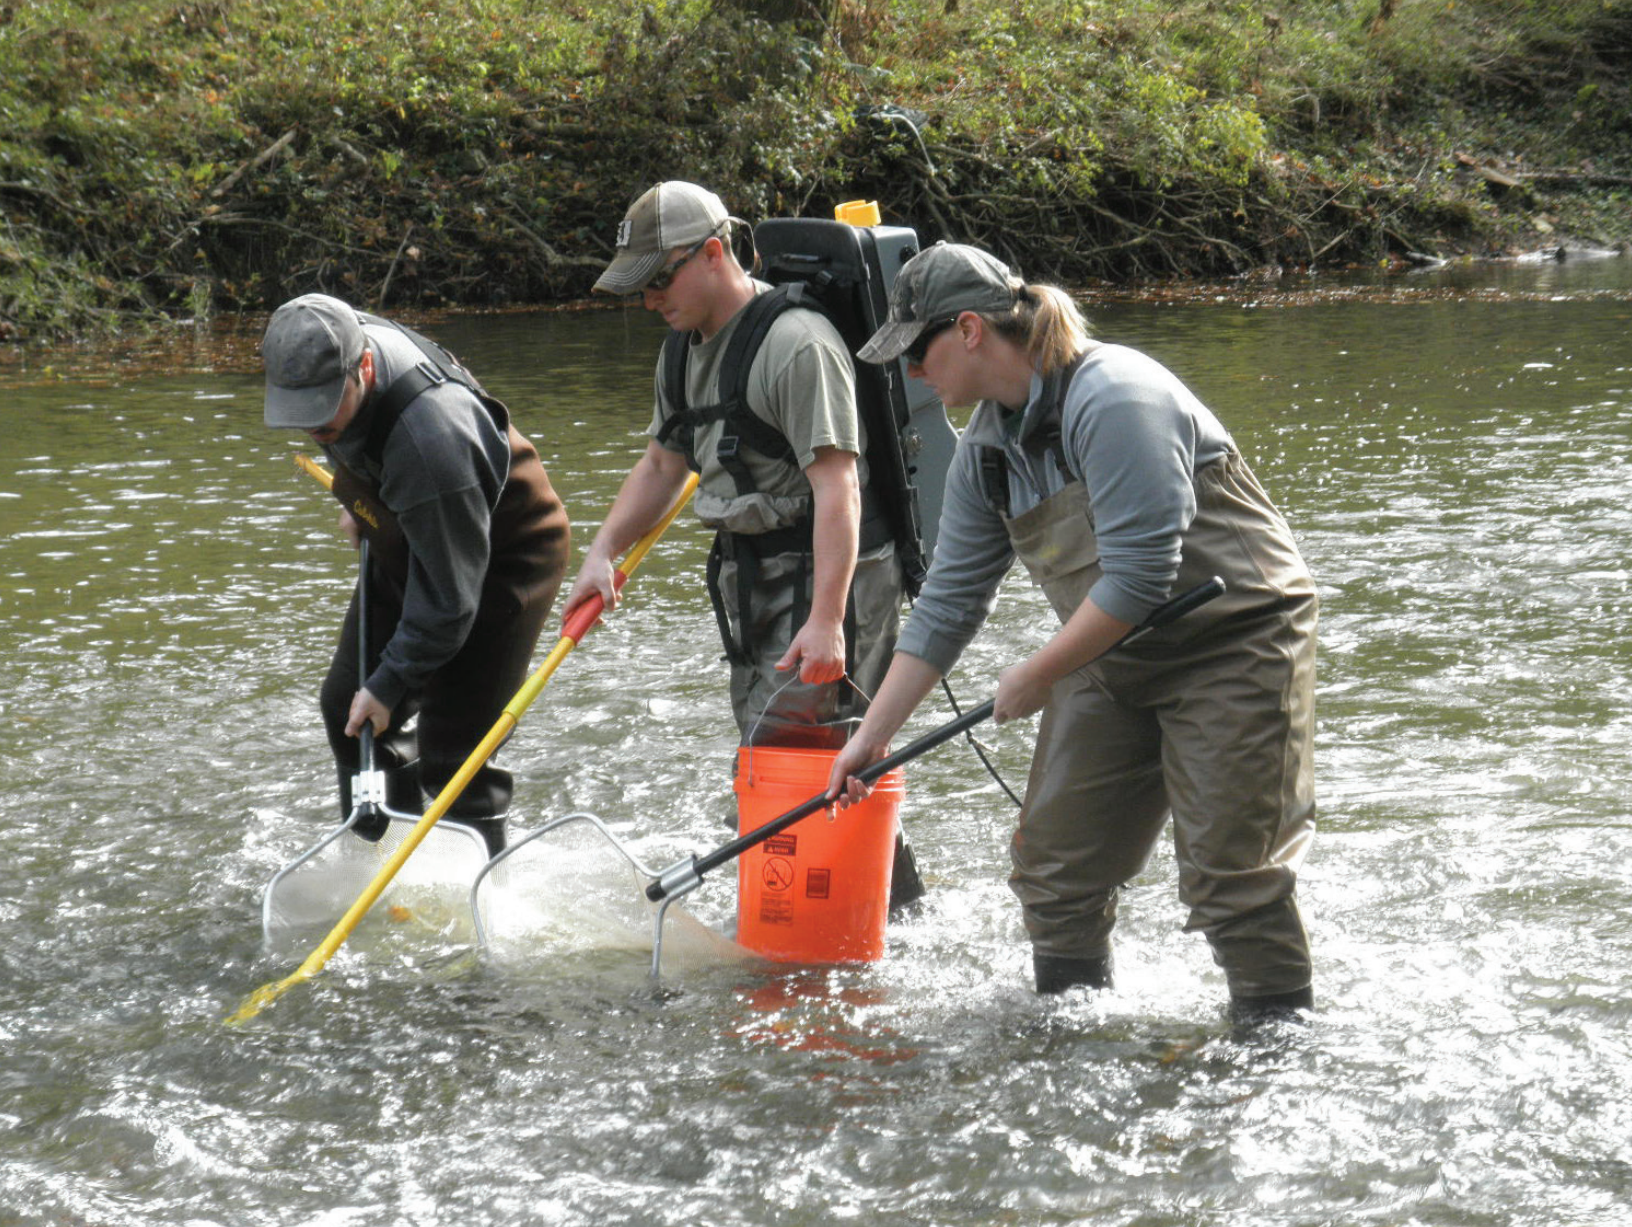
Fish are collected using a common scientific survey method known as electro-fishing. Electricity is used to stun fish before they are caught. This method is used to sample fish populations and normally the fish are returned to the stream unharmed in as little as ten minutes after being stunned. One person operates the equipment that stuns the fish while others catch the stunned fish with a net and place them in a bucket of stream water. The fish are identified and then returned to the stream.

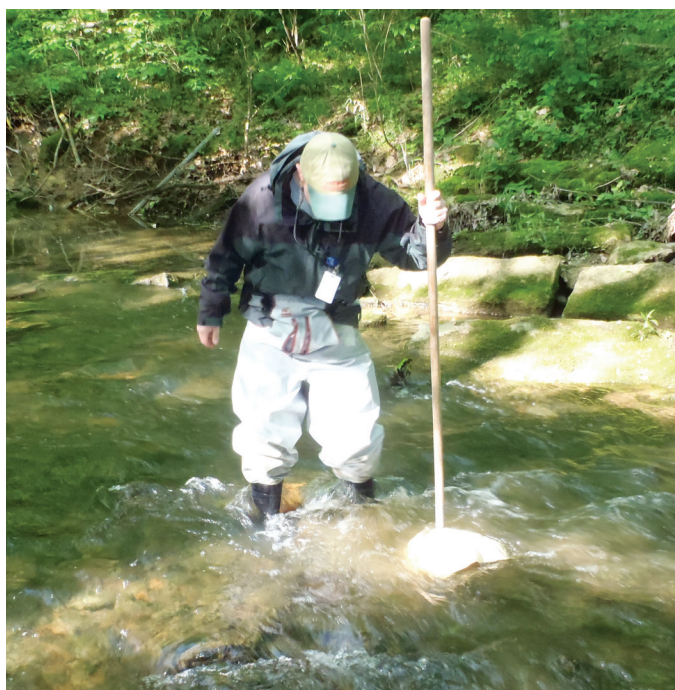
Biologist using a D-frame dip net to sample aquatic insects in a stream riffle.

Aquatic Insects: Many insects spend the early parts of their lives in water, including dragonflies, mayflies, damselflies and others. MSD collects aquatic insect community samples every two years using methods developed by the Kentucky Division of Water. Biologists use D-frame dip nets to collect the immature (larval) forms of insects that live in the gravel and other habitats in the bottoms of streams. The aquatic insects are sent to a laboratory and identified by biologists looking through a microscope.

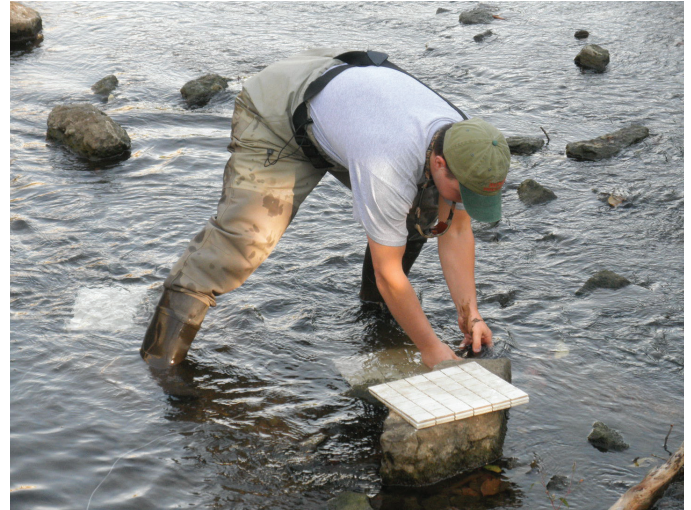
Placing ceramic tiles for collecting algae in the Middle Fork of Beargrass Creek.

Algae: Benthic (bottom dwelling) algae are a natural part of our streams and are a food source for some aquatic insects and fish. Algal communities change in response to changes in stream nutrient concentrations, sunlight, and the amount of sediment. MSD collects algal community samples every two years using methods developed by the Kentucky Division of Water. Biologists attach ceramic tiles to the stream bottom and leave them in place for at least 15 days. During this time, algae grow on the tiles. The tiles are frozen and sent to a laboratory where biologists identify and count the algae from the tiles using microscopes.

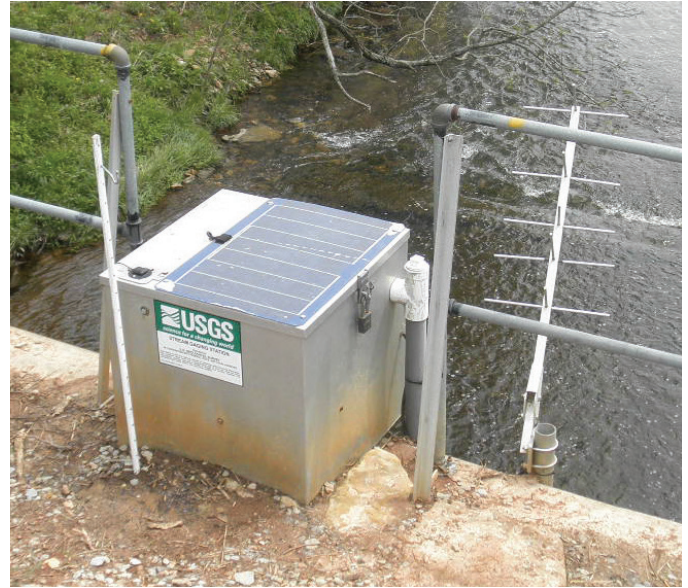
This USGS streamflow gage (gray box in photo) is located on Cedar Creek at Thixton Lane. This type of gage is used to continuously monitor stream temperature, dissolved oxygen, and stream flow. The antenna to the right of the box transmits data to a satellite for real time monitoring results via the web at <http://waterwatch.usgs.gov>

MSD and the USGS use permanent water quality meters to measure dissolved oxygen and stream temperature every 15 minutes at 24 of the 27 LTMN sites since 2000. Flow gages measure the stream flow every 15 minutes at 25 of the LTMN sites. The raw (draft) water quality and flow measurements are relayed to the USGS National Water Information System (NWIS) website in real time, and are available to the public. The USGS reviews and finalizes the data, then posts final data to the NWIS website. This level of effort highlights MSD's commitment to effectively monitor the quality and condition of streams in Jefferson County.

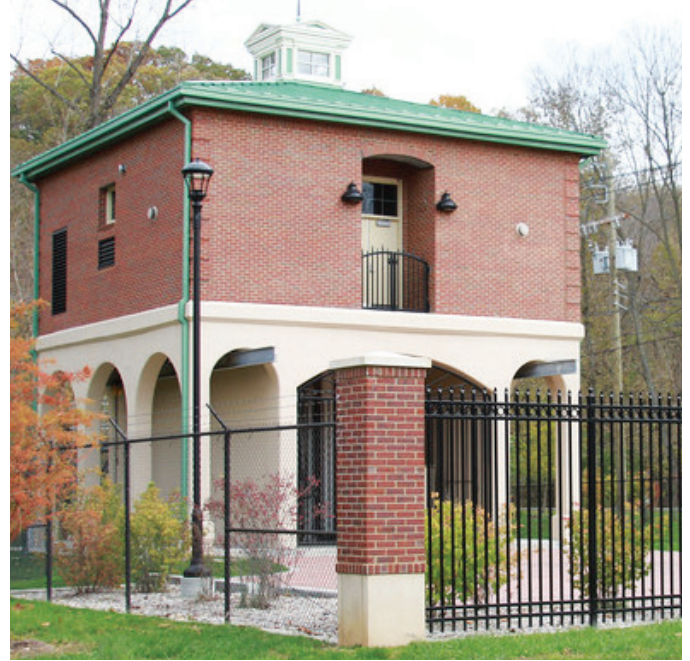
Mellwood Avenue Pumping Station

THE MELLWOOD AVENUE PUMPING STATION AT MOCKINGBIRD VALLEY ROAD HAS ELIMINATED AN OVERFLOW FROM THE EXISTING SEWER SYSTEM.
